Big Visual Data Analytics for Damage Classification in Civil Engineering

Chul Min Yeum¹, Shirley J. Dyke^{2,1}, Julio Ramirez¹, and Bedrich Benes³

Post-Disaster Damage Evaluation by Incorporating Big Visual Data

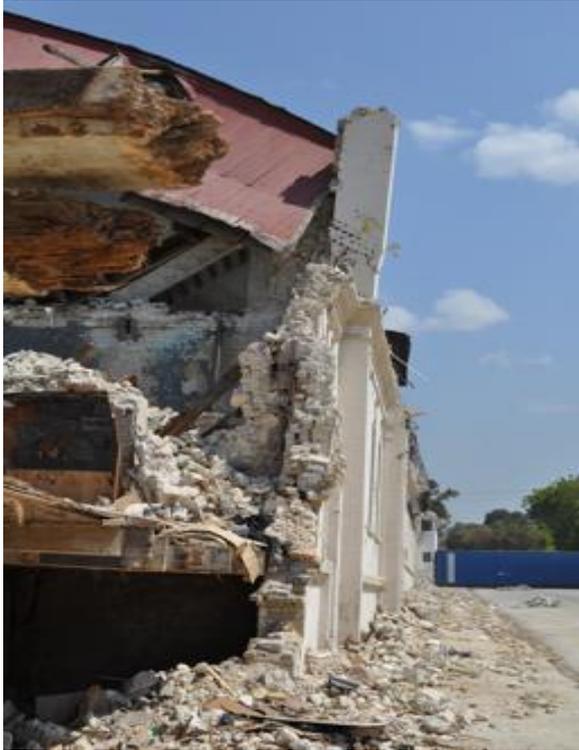
Collapse

Instance of a structure falling down or in.

Image showing that the buildings or building components

- lost their original shapes
- produce a large amount of debris
- are not serviceable or accessible

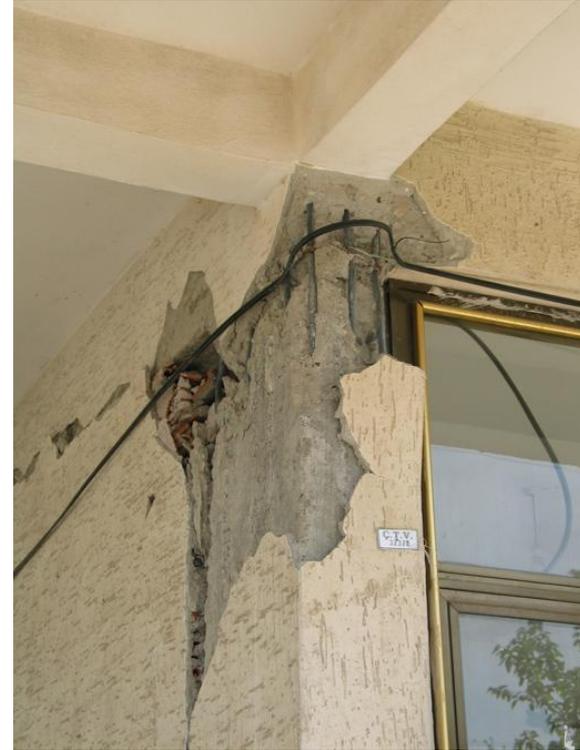
Spalling

Break off in fragments

Image including

- exposed masonry areas in a wall due to cracking followed by flaking
- exposed rebar in a columns
- small section lose due to large cracking in a concrete wall

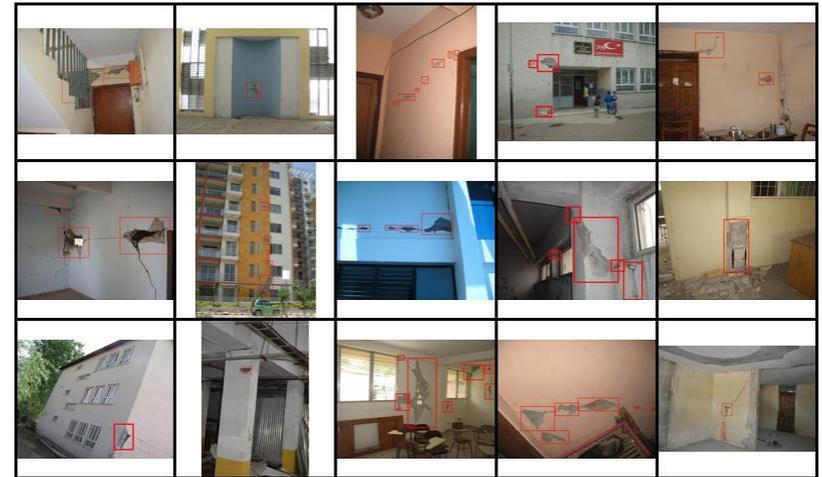
Spalling area annotation: 1,086 images

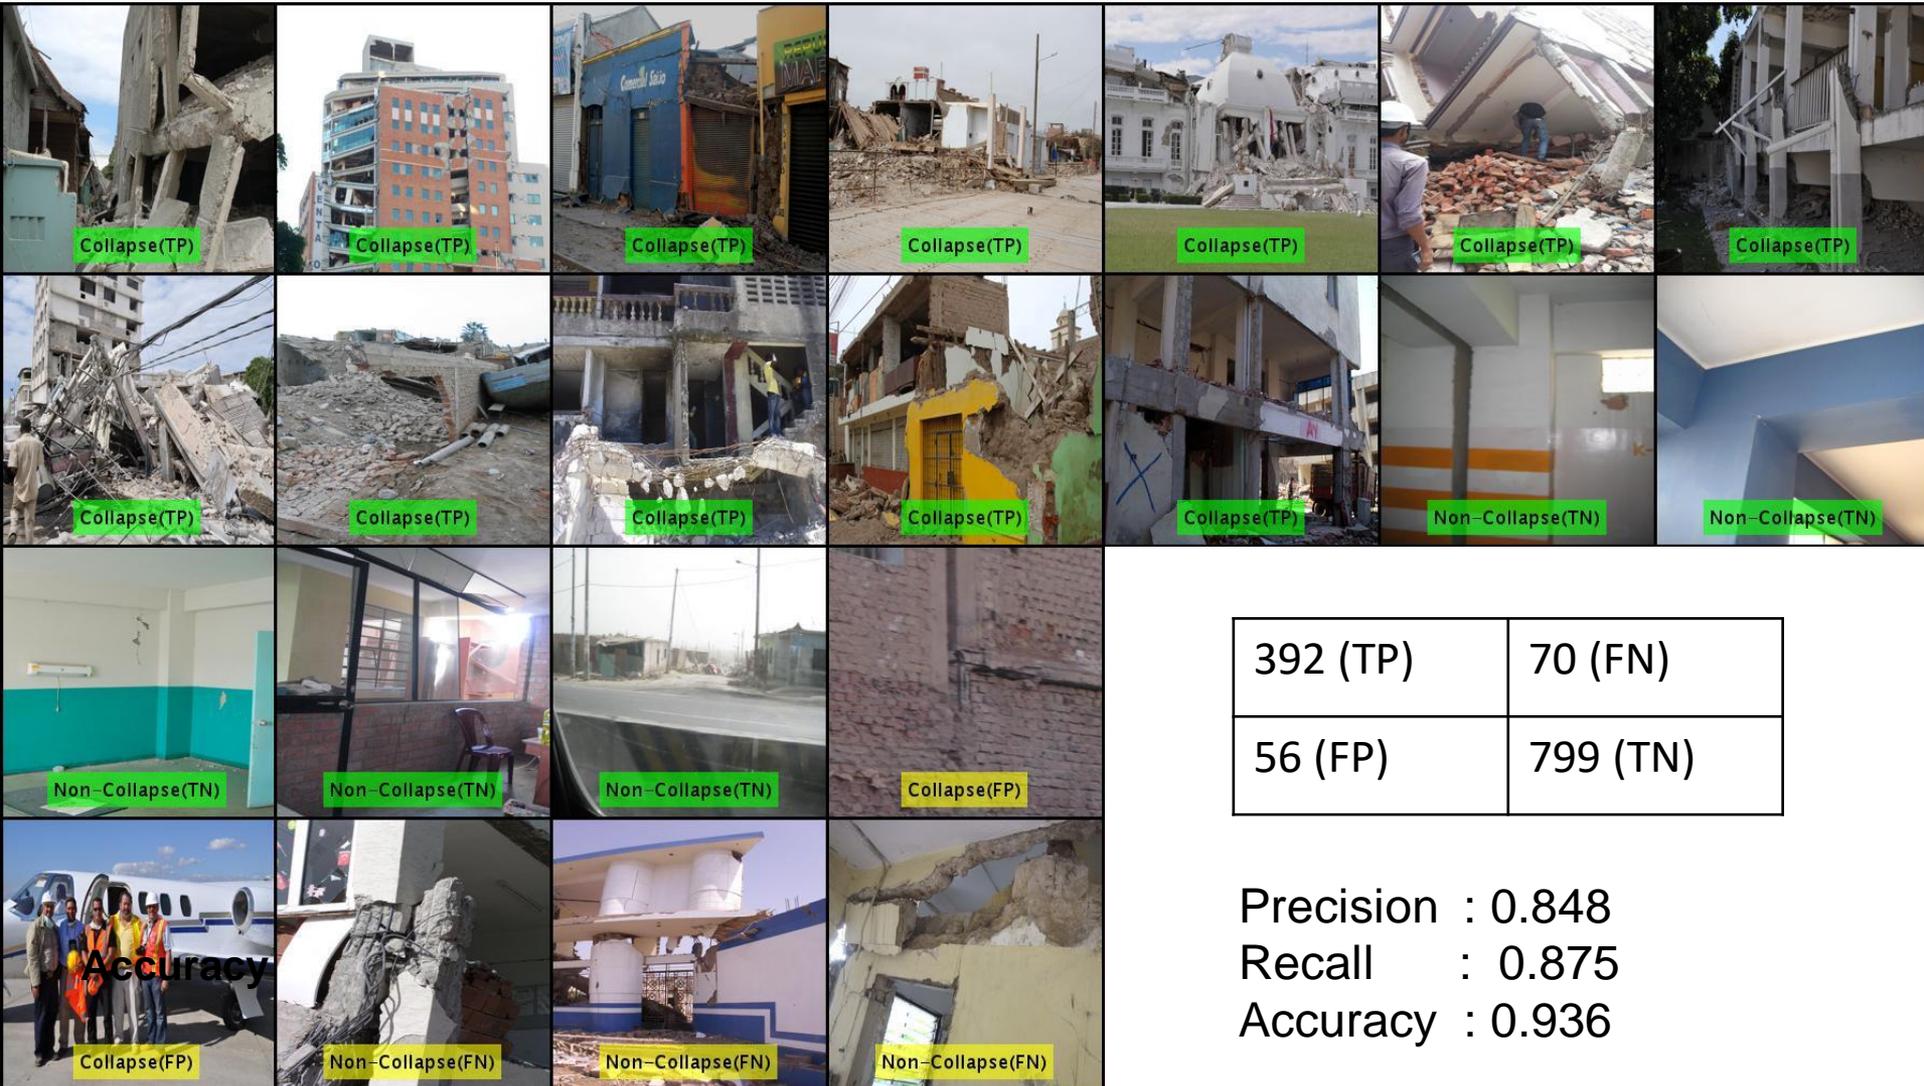
Result: Collapse Classification (Continue)

392 (TP)	70 (FN)
56 (FP)	799 (TN)

Precision : 0.848
 Recall : 0.875
 Accuracy : 0.936

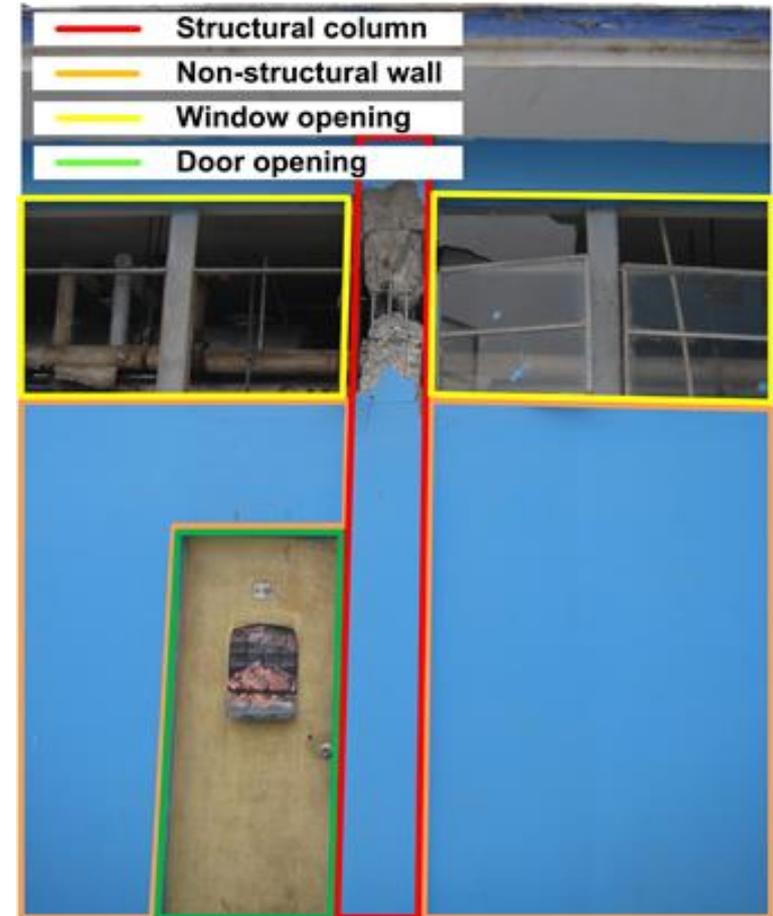
Spalling on a captive column
