# Automated Region-of-interest Localization and Classification for Visual Assessment

CHUL MIN YEUMS, JONGSEONG CHOI  
and SHIRLEY J. DYKE

## ABSTRACT

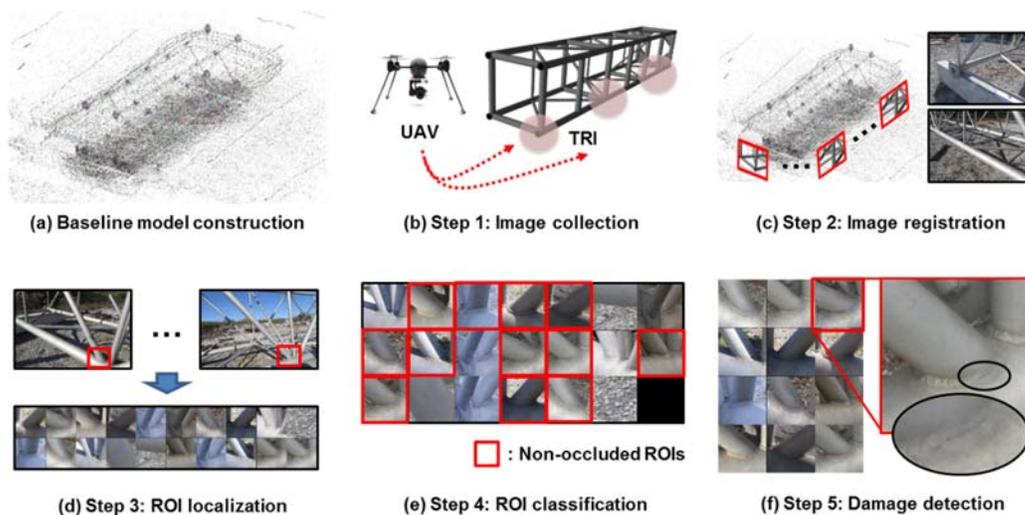
Figure 1. Overview of the technique developed: (a) construct a baseline model of target structure (pre-processing), (b) collect images around each of the targeted regions for inspection (TRIs), (c) register the images into the baseline model, (d) localize regions of interest (ROIs) on the images, (e) classify the favorable ROIs, and (f) detect (crack) damage on the ROIs.

In Fig. 1(a), as a preliminary step, a baseline model is constructed using SfM from a large volume of images collected around a target structure. The baseline model consists of 3D points with descriptors and calibrated images [3-4]. The 3D points in this

For actual visual evaluation, the test images are first collected from near each TRI in the structure, as shown in Fig. 1(b) and mentioned in the proposed visual evaluation scenario. The red blurred circles in the diagram indicate the selected TRIs for this structure. A large volume of images are first collected from different viewpoints and locations around each TRI. Next, in Fig. 1(c), the collected images are registered into the baseline model by matching the 3D points in the baseline model with the 2D features on the test images using their descriptors. Then, external (location and orientation) and internal camera parameters in each of test images are calibrated in the coordinate system of the baseline model. The geometric relationship between test images and each TRI in the baseline model is identified. Third, in Fig. 1(d), each ROI is extracted by mapping of the TRI on to each of the test images. Since the size of the ROI is computed by geometrically projecting the TRI on the image, the scale (size of the TRI in the ROI) is identical, improving the performance of damage detection algorithms. However, the visibility of some portions of the ROIs may be hindered by occlusions due to the complex geometry of the structure. To filter out such undesirable occlusion ROIs, a robust image classification algorithm, based on convolutional neural network algorithms, is implemented in Fig. 1(e). This binary occlusion classifier (BOC), is used to distinguish between the non-occluded and occluded ROIs, and is trained using manually labeled ROIs obtained from the baseline model. Then, the trained BOC is applied to the ROIs extracted from test images. Finally, damage on the TRI is detected on the classified ROIs in Fig. 1(f).

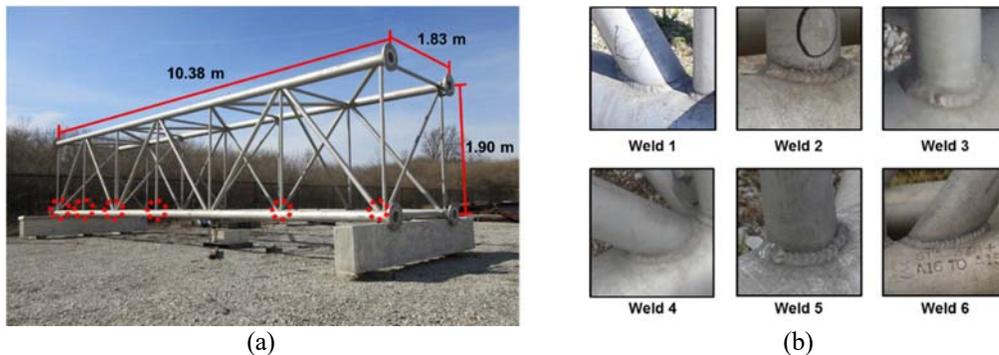
Figure 2. Description of a full-scale highway sign truss structure: (a) dimensions of the structure, and (b) six welded connections defined as the TRIs, which are marked as dotted red circles in (a).

For demonstrating the method developed here, a full-scale highway sign truss structure (hereafter, the test structure) is used, shown in Fig. 2(a). This structure was originally built for supporting highway message signs. Currently, it is located outside the Bowen Large-scale Structural Engineering Laboratory at Purdue University. The test structure is composed of six cubic segments. It has four main chords, twenty-eight vertical braces, twenty-four diagonal braces, and seven internal braces oriented

diagonally to the main chord. All members are tubular sections. The diameters of the main chord, vertical brace, and diagonal (including internal) brace are 152.4, 63.5, and 76.2 mm, respectively. The braces are connected to the main chords using welds.

Six fillet welded connections between the vertical or diagonal braces and main chords, which are regarded as critical components, are selected as TRIs for the test structure. As shown in Fig. 2(b), since tubular braces and tubular chords are connected, the shape of the weld is a warped circular line. The dotted red circles represent the TRIs. From right to left in Fig. 2(a), these are denoted as Weld 1 to Weld 6. Welds 2, 3, and 5 (denoted as Type 1) and Welds 1, 4, and 6 (denoted as Type 2) are created where the vertical and diagonal braces are attached to the main chord with diameter 63.5 and 101 mm, respectively.

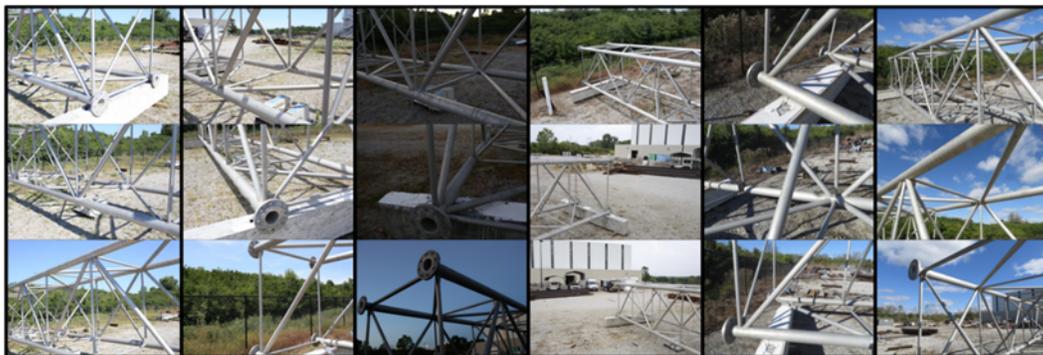
Figure 3. Sample baseline images used for constructing a baseline model: Images in each column are collected on different days and under different lighting and weather conditions.

To construct the baseline model for this verification, a total of 5,321 baseline images were collected from the test structure over five months. Images were collected on 11 different days at different times of day and/or weather conditions. Sample baseline images are shown in Fig. 3. Each column in this figure shows images captured on different days. Having such a large collection of images under various environmental conditions enables matching robust and unique features, that are invariant to environment changes, and have enhanced descriptors that normalize the variance resulting from varying lighting conditions. We do not fly a UAV, although image acquisition is designed to be representative of the process needed for practical use of this technique using UAVs. Thus, it is important to note that these images are acquired from locations that are not pre-determined.

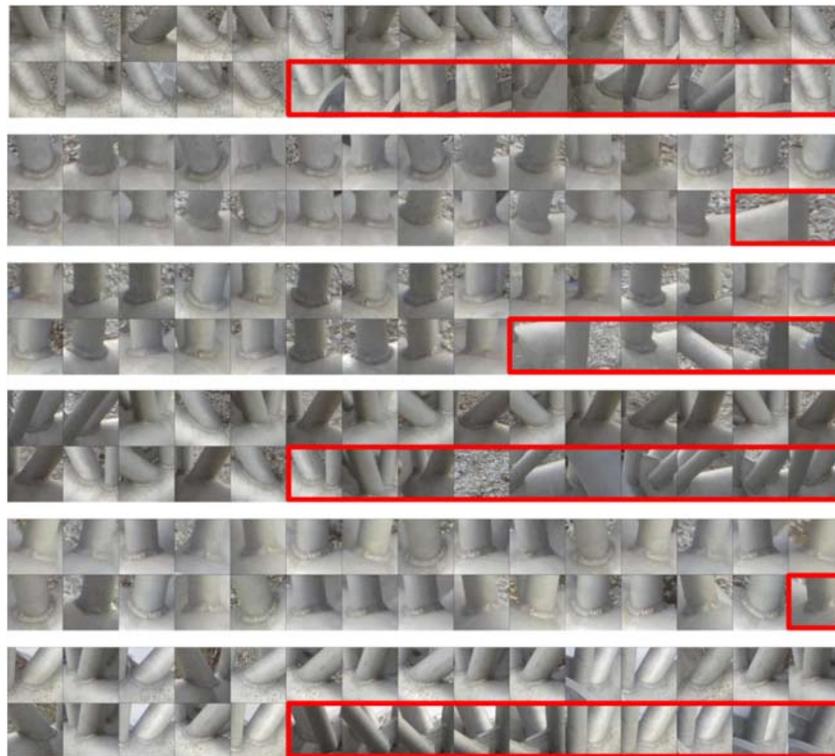
Figure 4. Examples of ROIs that have been localized and classified from the set of test images: Each set of 30 localized ROIs corresponds to Welds 1 to 6 (from top to bottom). A maximum of 10 negatively classified ROIs, are positioned at the end of the set (marked with a red box). The rest are classified as positive.

By the pairing between the 3D points in the baseline model and the 2D features in each test images, the projection matrices and one lens distortion parameter are calibrated. Based on the projection matrix associated with each test image, the ROI localization and classification outcomes are shown in Fig. 4. In each double row, 30 random localized ROIs are shown for Welds 1 to 6 from top to bottom. The actual number of localized ROIs is shown in Table I. Because any ROIs having insufficient resolution and not including the ROIs are rejected, the number of ROIs identified in these results are fewer than the total number of test images. Next, the trained BOC is applied to the localized ROIs to filter out the occluded ROIs that are not useful for visual evaluation. Among the 30 ROIs shown in Fig. 4, the ROIs that are classified as negative (with a

maximum of 10 shown), are added at the end of the list and marked with a red box. The rest of them are classified as positive. The total number of ROIs that are classified as positive and negative is listed in Table I. Also, after manually annotating the classified ROIs extracted from the test images, the precision in classification is computed. Overall the performance of this classifier is successful based on its high precision. Such high precision, which is the number of true-positives over the number of positives, implies that when reliable damage detection methods are applied to these ROIs, they are unlikely to produce false-positive errors because the most of the positive ROIs are true-positive (non-occluded) ones.
