Automated Damage Evaluation for Big Visual Data Collected from Earthquake

C.M. Yeum¹, S. J. Dyke¹, J. Ramirez¹, and C. Sim²

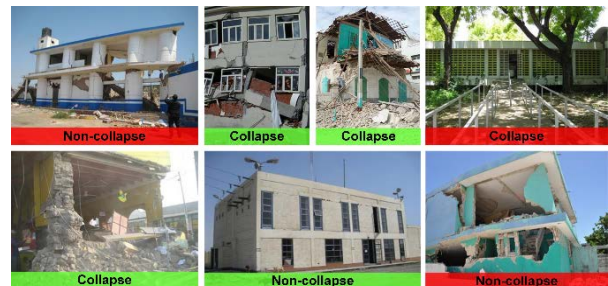
Figure 1. collapse classification results. Note that text labels indicate classification results and green and red colors are true and false estimation.

We obtain rates of 90.26% (417/462 images) true-positive (true classification of collapse images) and 92.16% (788/855 images) true-negative. The precision is 0.862, defined as the number of true-positives over the number of positives. Random samples of testing results with their predicted labels are shown in Figure 1.
