3D Damage Quantification for Visual Inspection

Presented at 8WCSCM 2022
June 06, 2022

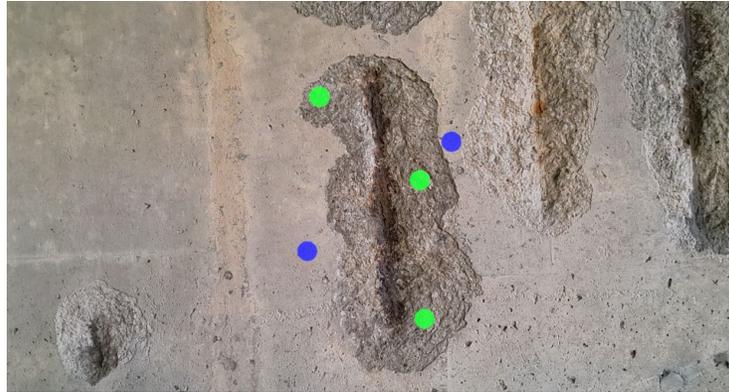
- Step 1: User selects seed points inside and outside damage region

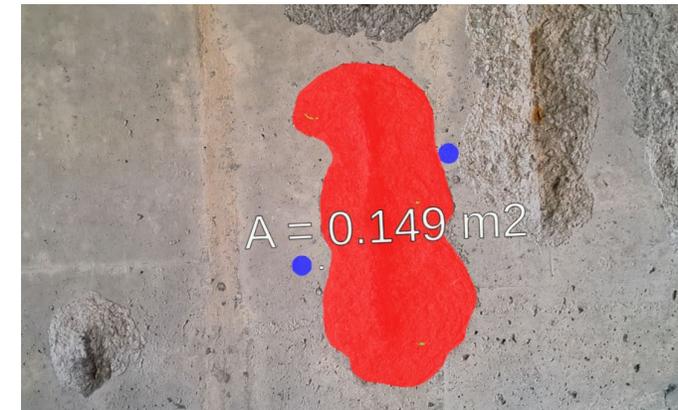
- Step 4: Calculate area of final segmented damage region

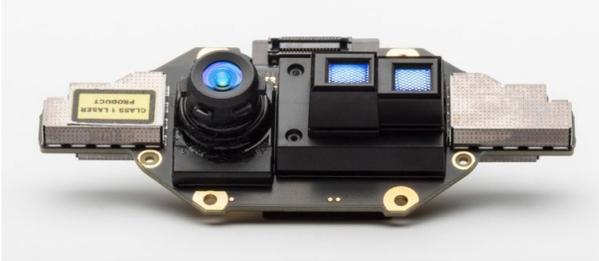
Infrared (IR) Depth Sensors

Mode	Resolution	FoV	FPS	Operating range*	Exposure time
NFOV unbinned	640x576	75°x65°	0, 5, 15, 30	0.5 - 3.86 m	12.8 ms
NFOV 2x2 binned (SW)	320x288	75°x65°	0, 5, 15, 30	0.5 - 5.46 m	12.8 ms
WFOV 2x2 binned	512x512	120°x120°	0, 5, 15, 30	0.25 - 2.88 m	12.8 ms
WFOV unbinned	1024x1024	120°x120°	0, 5, 15	0.25 - 2.21 m	20.3 ms
Passive IR	1024x1024	N/A	0, 5, 15, 30	N/A	1.6 ms

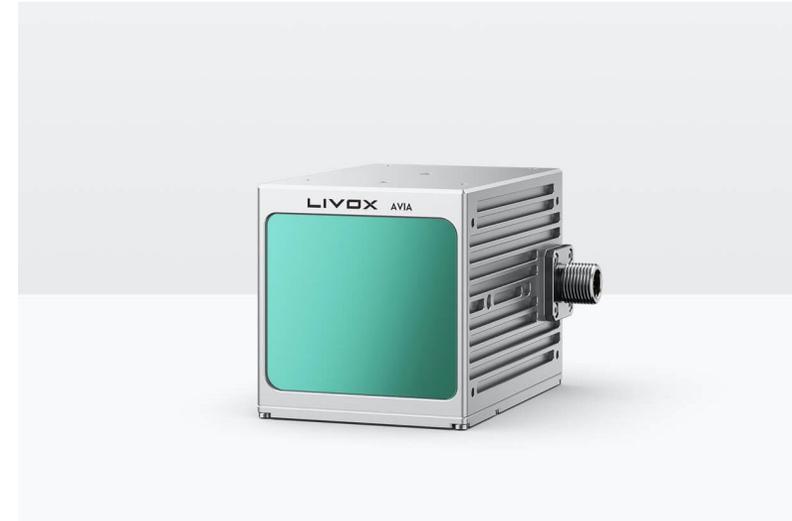
LiDAR

Range Precision (1σ @ 20m)

2 cm¹

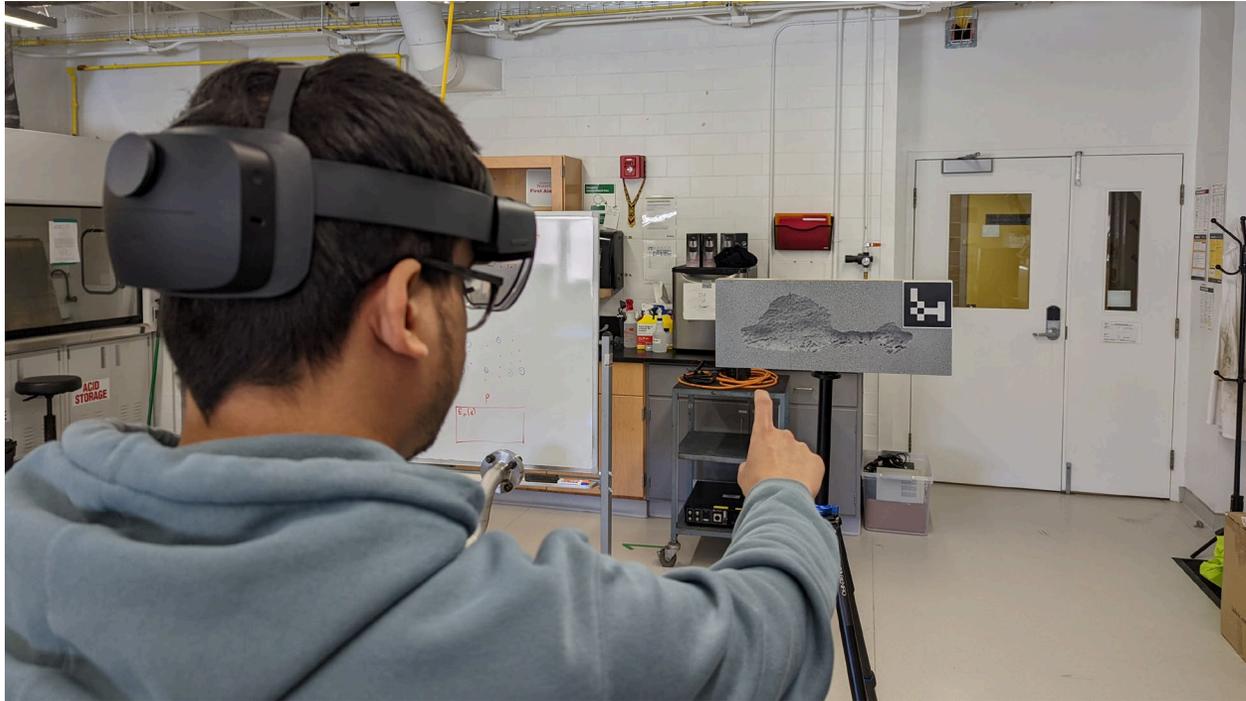
Step 1. Data Collection Using a Hololens 2

Photo capture via a gesture control

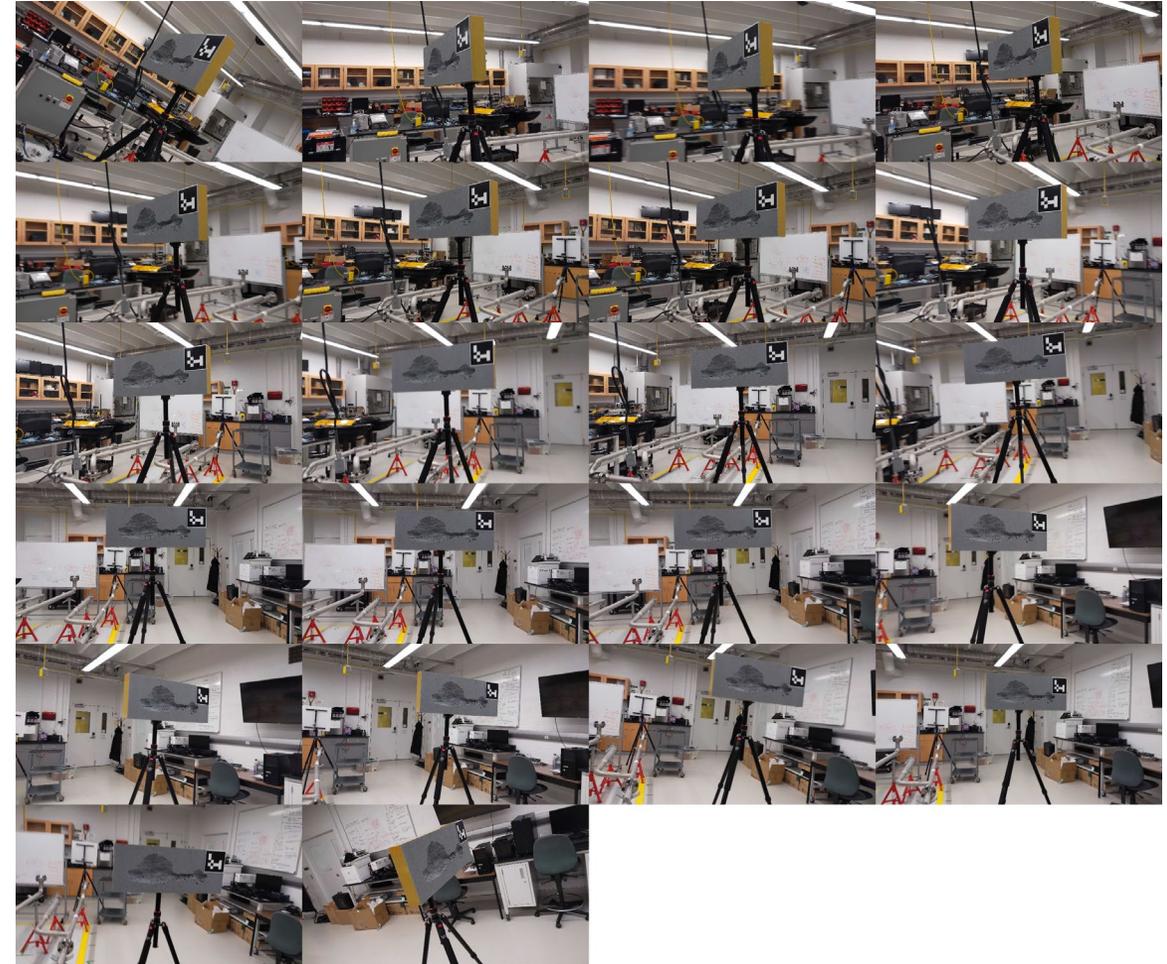
Image collection from different angles

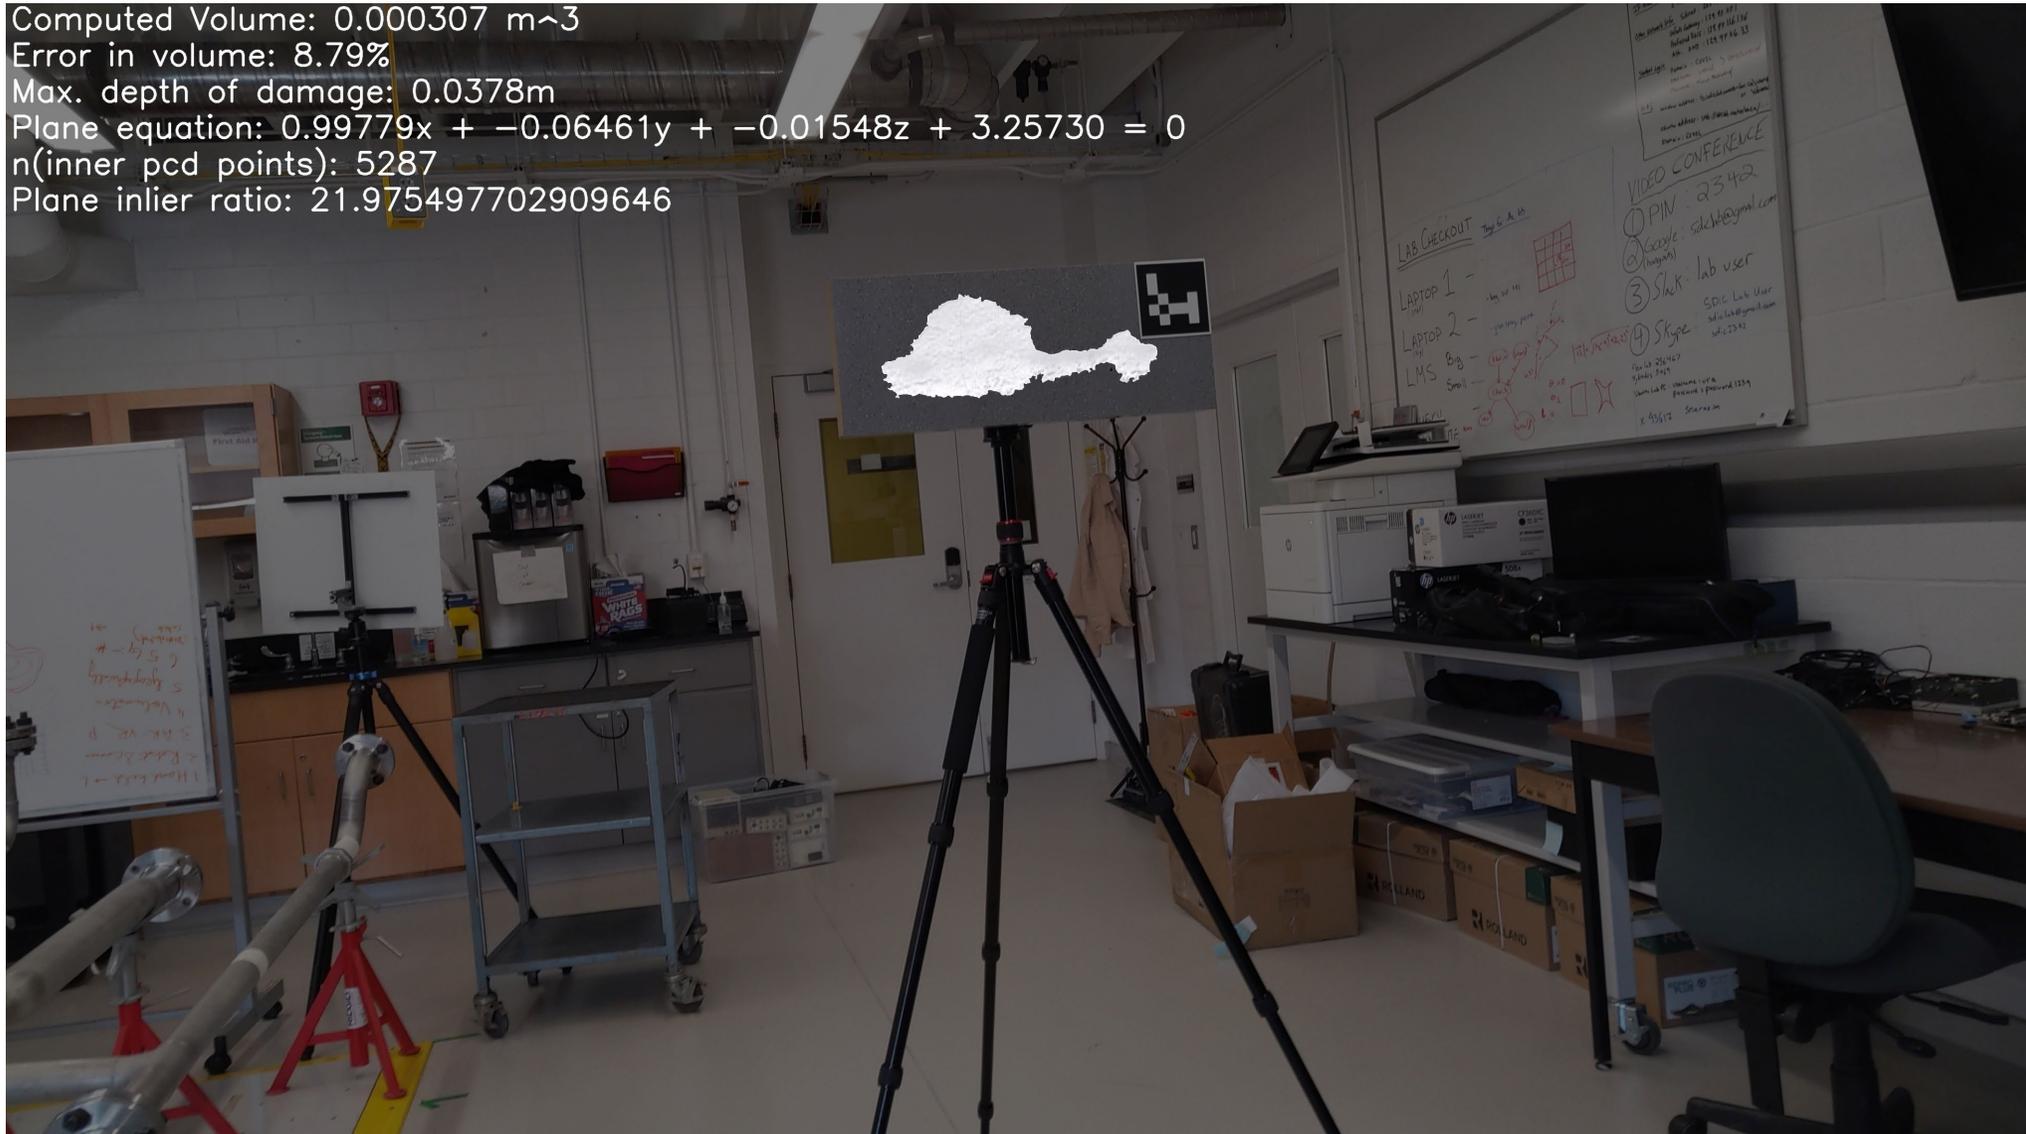
Laboratory Test Result

Computed Volume: 0.000307 m³

Error in volume: 8.79%

Max. depth of damage: 0.0378m

Plane equation: $0.99779x + -0.06461y + -0.01548z + 3.25730 = 0$

n(inner pcd points): 5287

Plane inlier ratio: 21.975497702909646

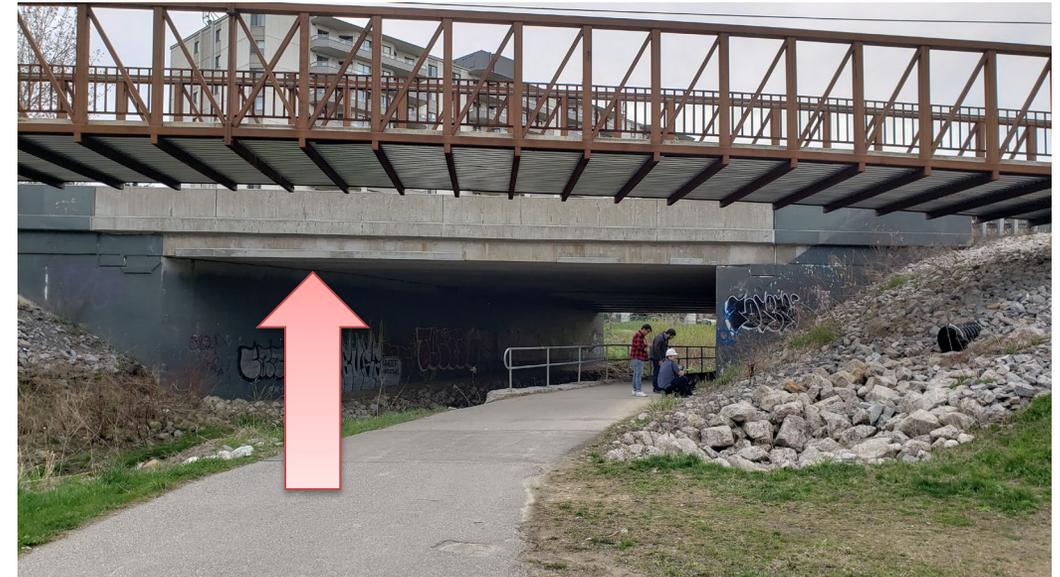
On-Site Experiments: Test Structure

Structure ID	Structure Name	Structure Subtype	Location Description	Install Date	Number of Spans	Deck Length	Deck Width	Deck Area
2805_1	Homer Watson Boulevard/ Balzer Creek	Beam/Girder	0.73 km North of Bleams Rd	1/1/1978	1	18.3	11.2	204.9

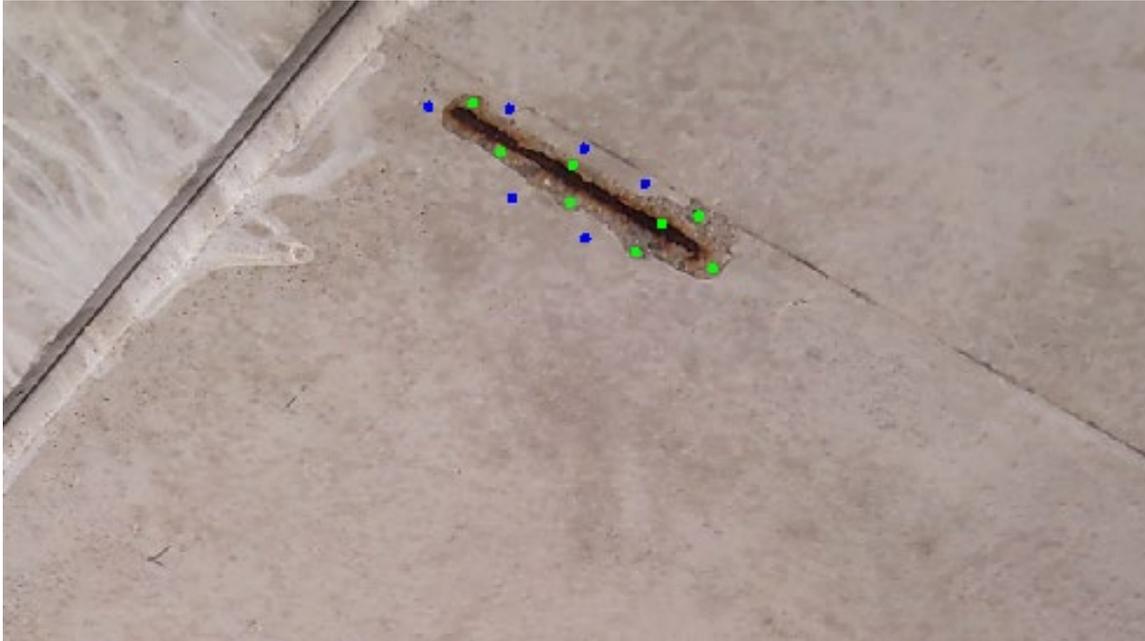
Step 1: User selects seed points inside and outside damage region

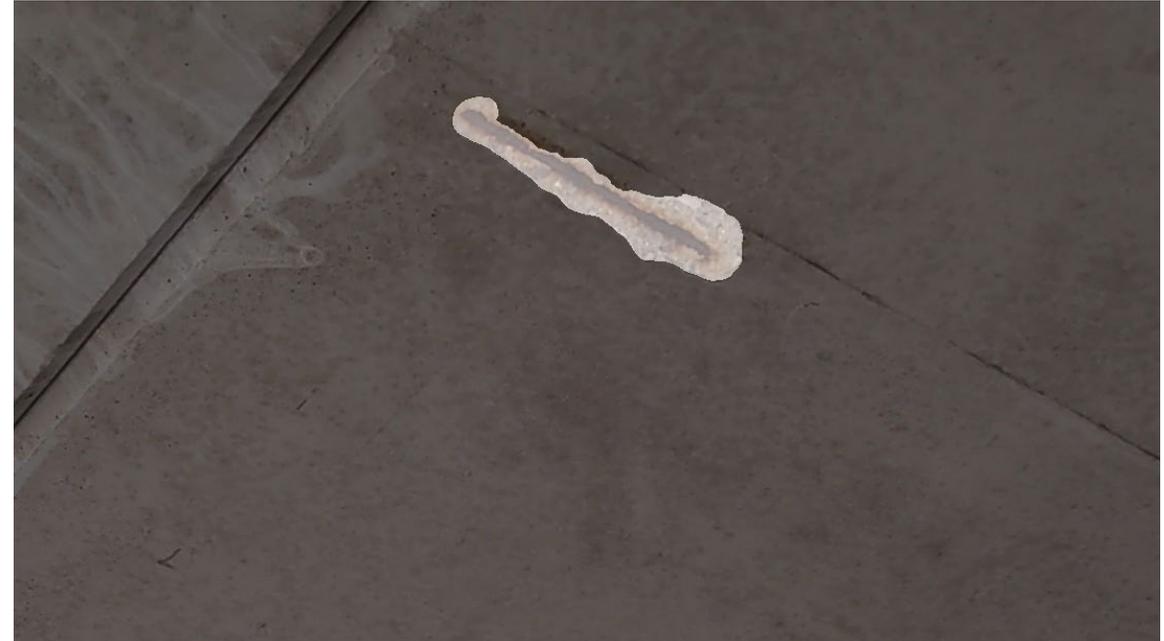
Step 2: Capture image and apply interactive segmentation algorithm

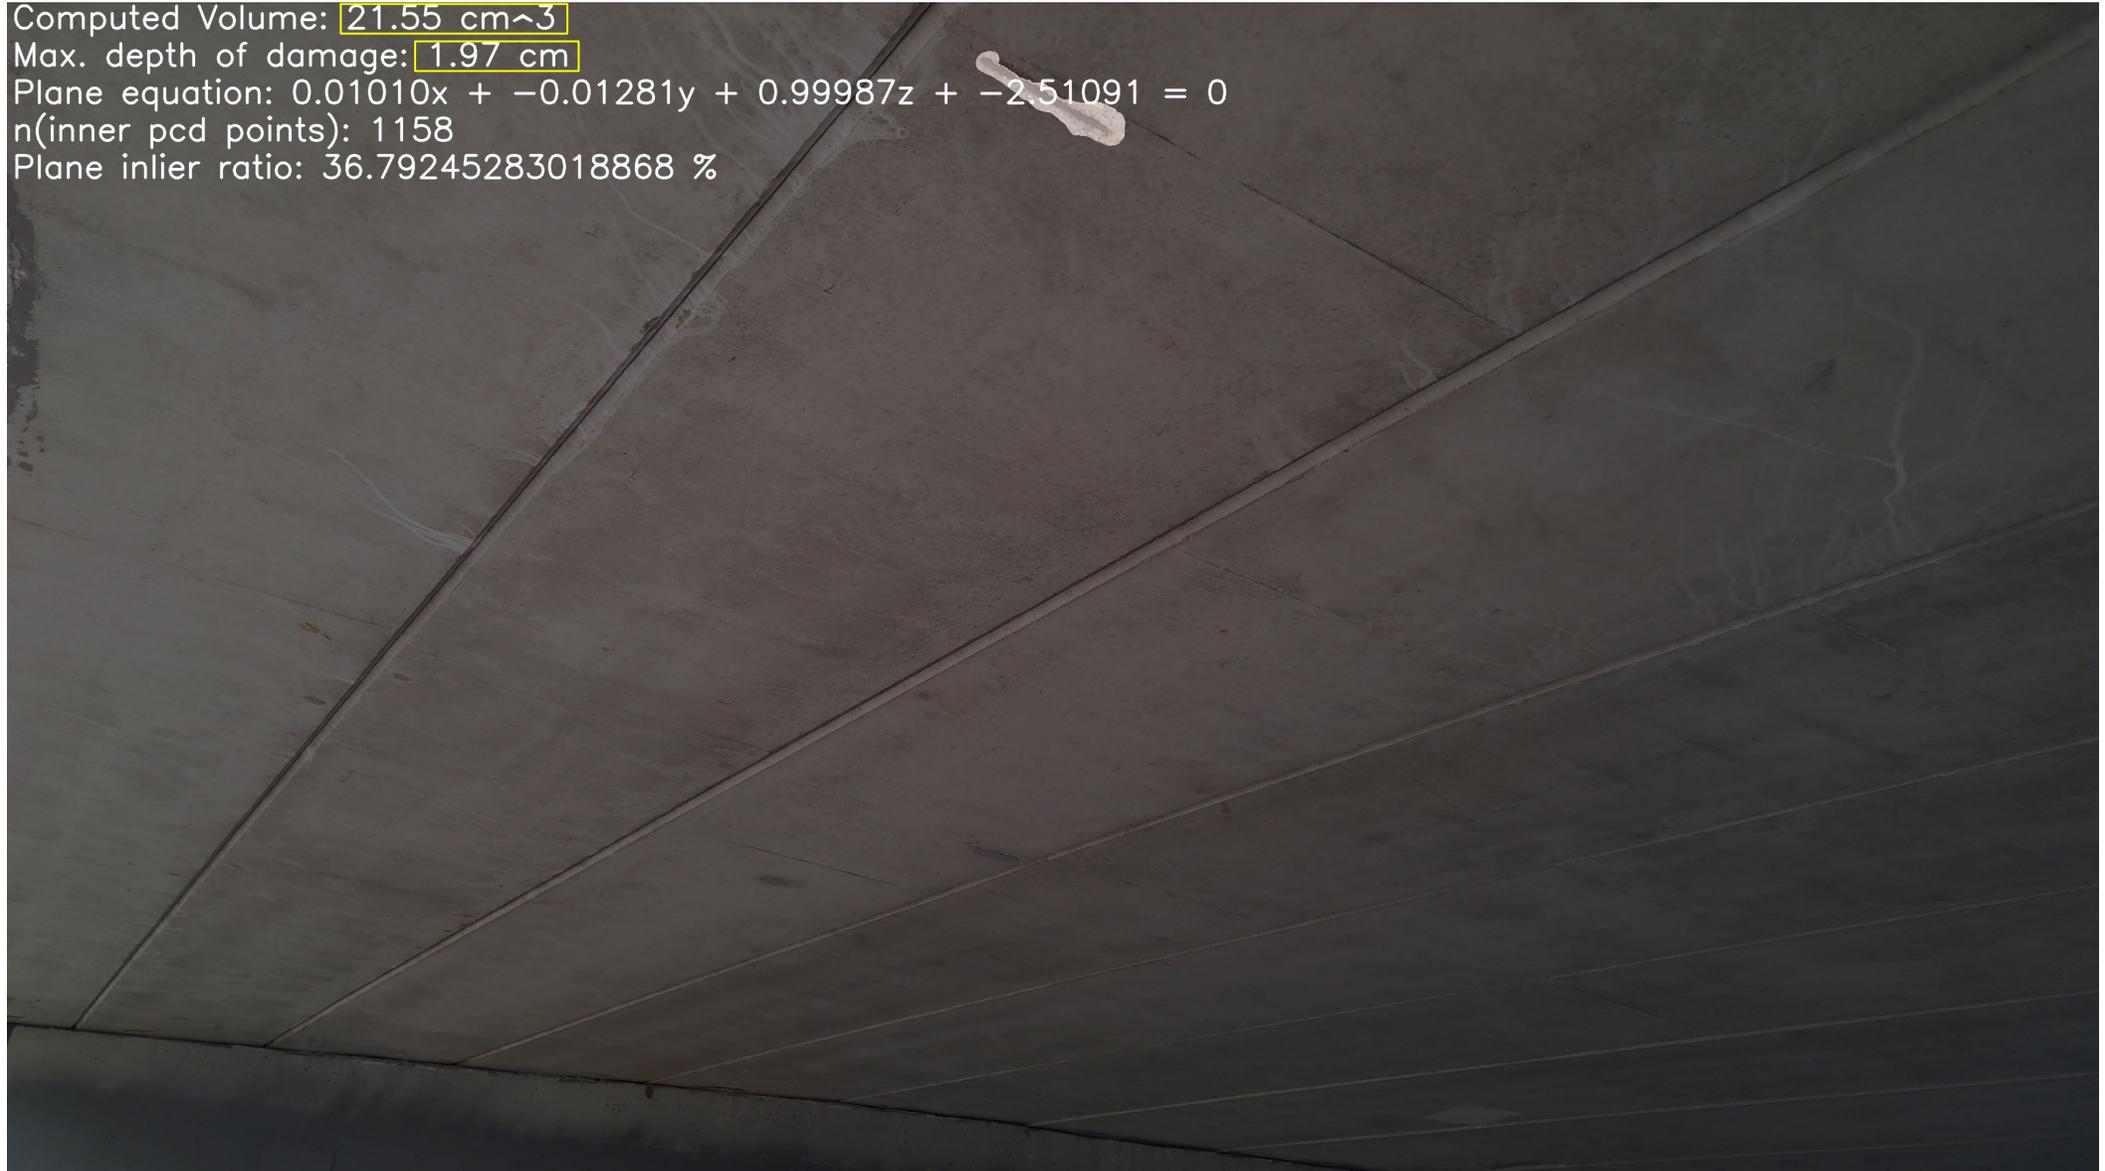
Damage Quantification Result

Computed Volume: 21.55 cm³

Max. depth of damage: 1.97 cm

Plane equation: $0.01010x + -0.01281y + 0.99987z + -2.51091 = 0$

n(inner pcd points): 1158

Plane inlier ratio: 36.79245283018868 %
